Assessment of landslide-induced damage to structures: the Agnone landslide case study (southern Italy)

Keywords Landslides · Structurally complex formations · Damage classification · Buildings · Agnone

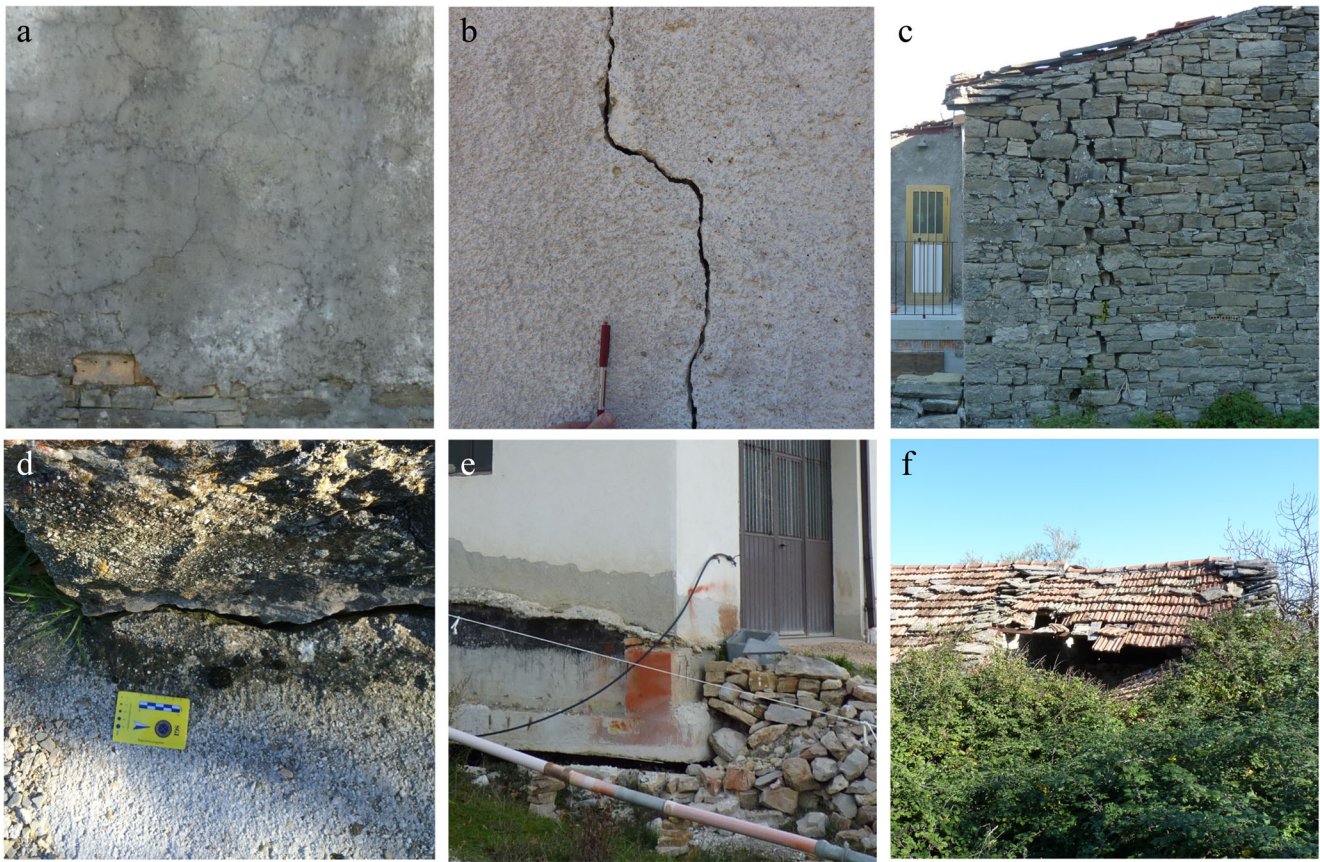
- hairline cracks (Fig. 7a);
- open fractures on external walls (Fig. 7b and c);
- ruptures between walls and external pavements (Fig. 7d and e); and
- in rare cases, roof collapses (Fig. 7f).

Fig. 7 Damage identified on buildings. a) Hairline crack in the plaster of a masonry wall; b) open crack, approximately 1.0–1.2 cm wide, in a wall of a reinforced concrete building; c) open crack, approximately 4 cm wide, in a wall of a masonry building; d) open crack between a wall

and the pavement in a masonry building; e) open crack, more than 10 cm wide, between a wall and the ground surface of a reinforced concrete building; f) collapsed roof in a masonry building

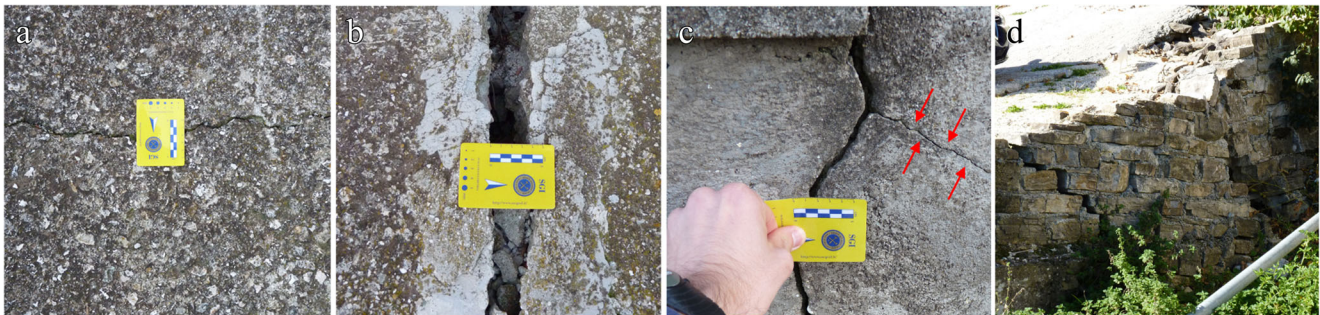
- hairline cracks (Fig. 8a and the red arrow in 8c) and
- open cracks (Fig. 8b–d).

Fig. 8 Damage recognized on concrete slabs and walls. a) Hairline crack in pavement; b) open rupture in a slab; c) hairline (red arrows) and open fractures in a concrete wall; d) damage to a masonry wall

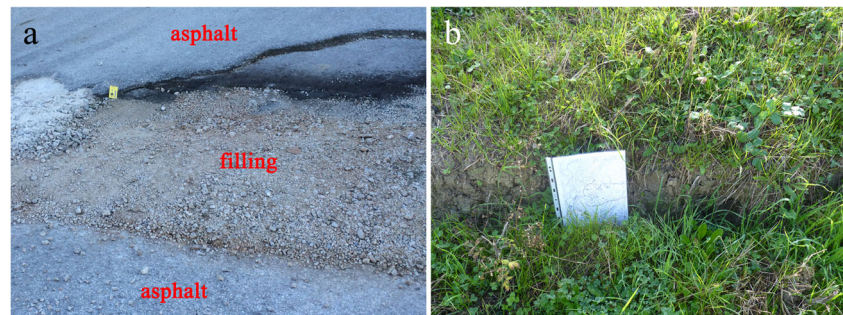
Cracks recognized on the ground (Fig. 9b) or on pavements (Fig. 9a) were plotted on a topographic map and photographed as well as spatially identified with a GPS tracker.

Fig. 9 Cracks located close to the landslide on (a) the pavement of a road and (b) the ground surface. In photograph (b), a vertical slip is recognized

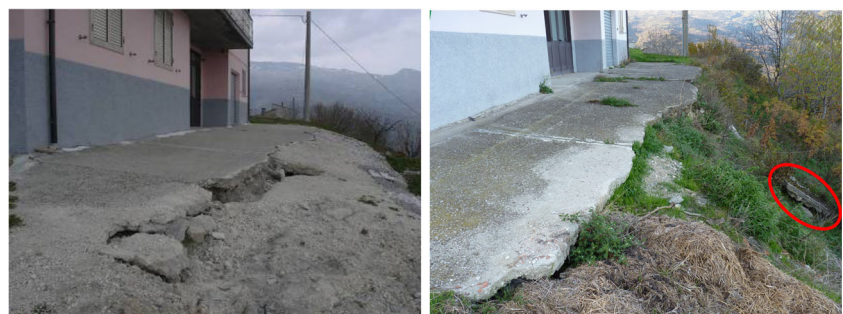
An example can be made taking into account a sidewalk made of reinforced concrete (Fig. 10) that is located in the present crown of the landslide that currently shows an important open crack pattern with detachment of a portion (Fig. 10b). In recent years, the crown of the landslide has retrogressed, widening its boundaries and increasing its dimensions, as reflected in the opening of new tension cracks and the collapse of a part of the sidewalk bordering a building that does not show severe damage to the external façades.

Fig. 10 Evolution between 2003 (left) and 2015 (right) of a reinforced concrete perimeter sidewalk of a building located on the crown of the landslide

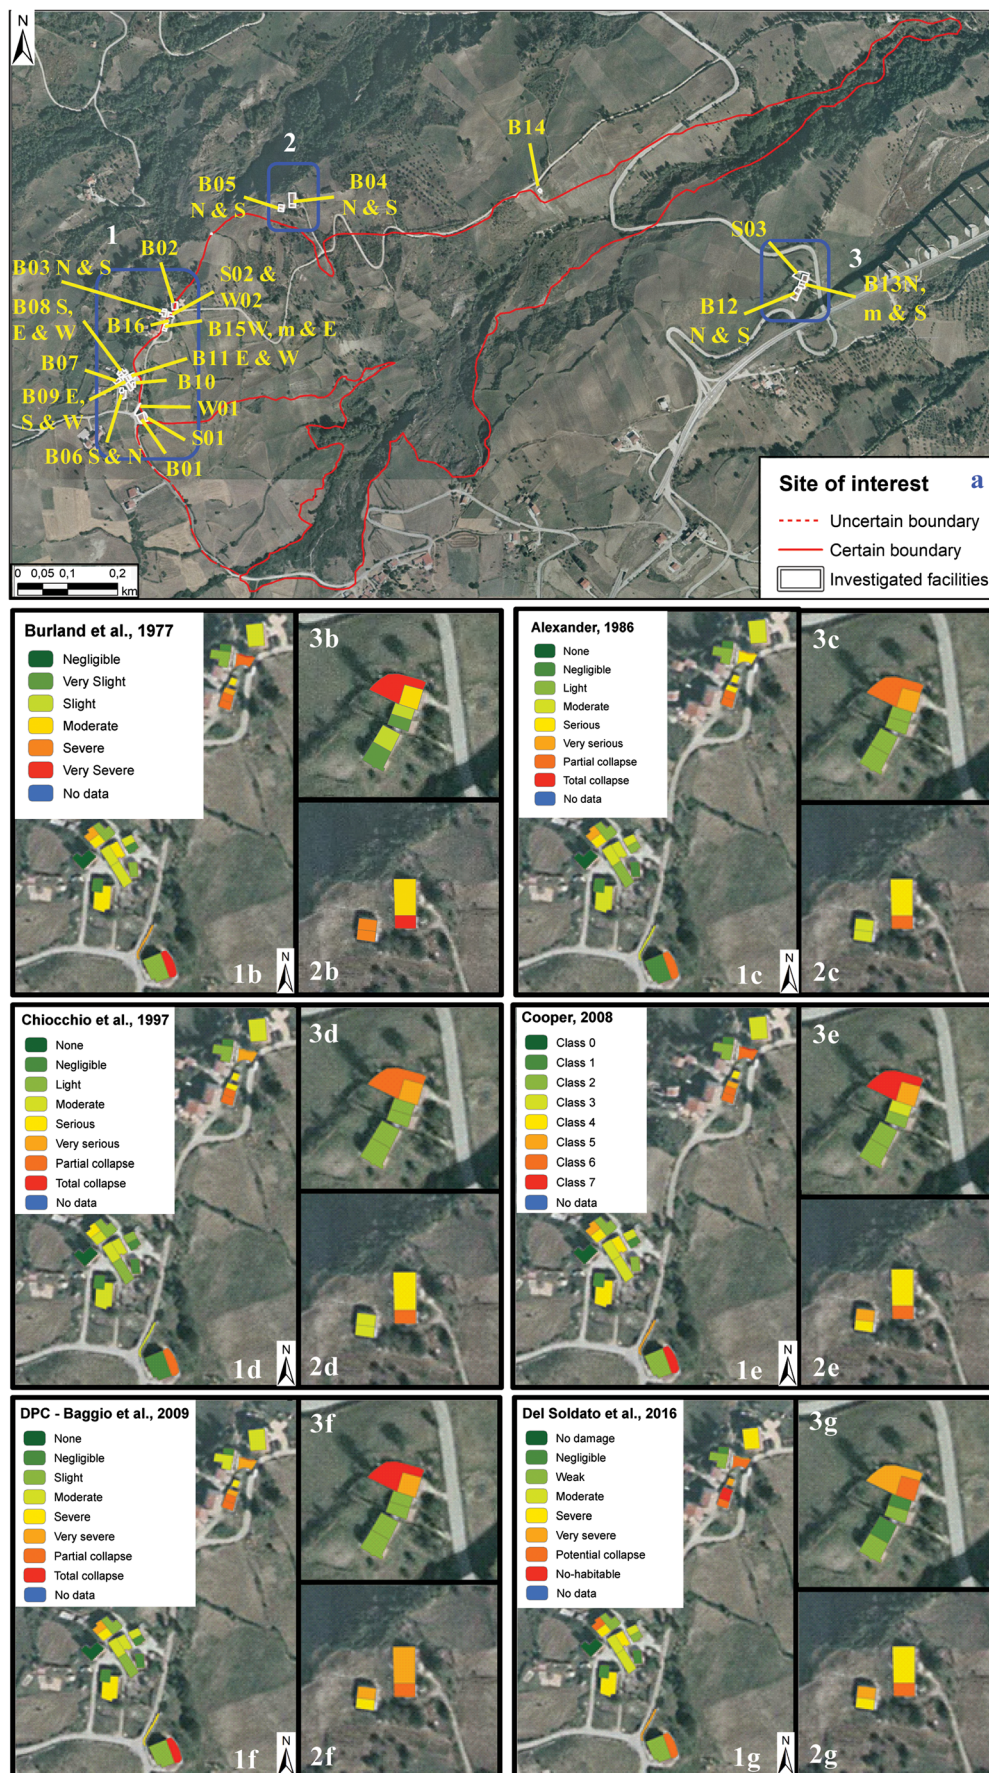
Following the classification of Burland (1977) (Fig. 11b), a large number of buildings (approximately 50%) present *Slight* and *Very severe* damage, as several abandoned structures are strongly affected by damage and have partially collapsed. Only two buildings have been assigned to the *Negligible* class, and four fall into the *Very slight* class. Negligible damage were observed in more recent structures, in a small house that was probably renovated in recent times and in buildings that were built further from the landslide than the others. The *Very slight* class includes a building located on the present-day crown of the landslide. This rank is due to the low level of damage present in its façades, although important damage could affect its foundation.

Alexander's (1986) (Fig. 11c) classification measures crack apertures in centimeters instead of millimeters. This implies that the classification is less sensitive to damage, and most of the facilities are grouped into the *Light* and *Moderate* classes. Additionally, in this classification, “evacuation and rapid attention to ensure” is recommended for those facilities that exhibit *Moderate* damage. Concerning the buildings located on the crown of the landslide, this methodology classifies the damage as *Negligible*, despite the

existing high risk. Another noteworthy point is that this methodology considers two categories for buildings that are strongly affected by damage: *Partial collapse* and *Total Collapse*. The nine buildings assigned to the *Very severe* class using the Burland (1977) approach are divided into three classes according to Alexander's (1986) classification: three of the buildings fall into the *Very serious* class, five fall into the *Partial collapse* rack, and one falls into the *Total collapse* category.

The Chiocchio et al. (1997) (Fig. 11d) approach also measures cracks in walls using centimeters. However, this approach includes the construction distinction between masonry and reinforced concrete, in contrast to the previously mentioned methodologies. In this way, structures affected to a significant degree by rigid settlement, which were previously assigned to the low damage classes, are grouped with those affected by several cracks. A concentration of buildings is assigned to the *Light* and *Moderate* damage classes, and the authors suggest evacuation even for the *Moderate* category. Moreover, it is important to note that using this categorization, the building (B01) located on the probable present-day crown of the landslide has few, narrow visible cracks in its external façades, perhaps justifying the low damage classes assigned by the classification, despite an important rupture that affects the front concrete sidewalk. Six buildings, probably abandoned several years before the main event, are assigned to the highest categories of damage (i.e., *Partial collapse* and *Total collapse*), as in the Alexander (1986) approach.

In his approach, Cooper (2008) (Fig. 11e) introduces the description and categorization of landslide ground damage in addition to the classification of the damage recognizable on facilities and buildings. This classification uses millimeters to measure the opening of the cracks that appear on the elements of the investigated structures. In our case study, the classification assigns an important number of buildings to *Class 3*, compatible with the *Moderate* category of the other approaches. Comparing the proposed classification with the other areas, more facilities are sorted into the higher levels of damage. This is probably due to the method's higher

sensitivity in assessing damage that is caused by the use of the millimeter as the unit of measurement, and it is a more appropriate methodology for classifying ruptures that affect some facilities, such as pillars, walls, and concrete sidewalks.

The DPC approach (Baggio et al. 2009) divides the level of damage into four classes, although the classification includes eight damage classes: two low levels (*None* and *Negligible*), four categories representing significant damage (*Severe*, *Very severe*, *Partial*, and *Total collapse*), and two intermediate grades (*Slight* and *Moderate*) (Fig. 11f). This approach provides a more evenly distributed classification of damage (thus most of the buildings are not ranked into only one or two classes) than the previous described and applied approaches. Despite the small number of facilities located in the study area, an increasing number of structures are ranked into the categories reflecting high levels of damage (*Severe* and *Very severe*). This methodology gives more attention to damaged buildings since it was conceived to evaluate the fitness for human habitation of structures after a damaging seismic event.

The Del Soldato et al. (2017) categorization provides a homogeneous distribution of the structures located in the landslide-prone area due to its simple but detailed approach that includes two phases. These two steps of damage evaluation and subsequent structure assessment in sensu stricto allow a better discrimination of the severity of cracks and fractures. Similar to the Cooper (2008) approach, the investigation takes into account the external portions of the structures eliciting an increment in the low ranks of the buildings affected by weak fractures in external façades but relevant fractures and displacement in the foundations. Several

◀ **Fig. 11** a) Localization of the investigated buildings and facilities with their damage classifications according to b) Burland et al. (1977), c) Alexander (1986), d) Chiocchio et al. (1997), e) Cooper (2008), f) DPC (Baggio et al. 2009), g) Del Soldato et al. (2017)

constructions are categorized in the low ranks of damage (*Negligible* and *Weak*), and a relevant number is characterized by important damage (*Moderate* and *Severe*). In the left flank of the landslide (i.e., area 2), the constructions are categorized with a high level of damage (*Severe* and *Very severe*) due to the important displacement caused by a double component of movement. The first displacement component affects the right side of the study area that is under the influence of the CL-PO landslide. The second component is due to an enlargement of the mass movement that affects the neighboring basin. The three sidewalks and the two investigated walls are all categorized into a high level of damage (*Severe* and *Very severe*) due to the open cracks and fractures that affect them and, in one case, the detachment of a portion of the sidewalk due to the regression of the landslide border. Only one edifice is featured by *No damage* due to its recent construction or renovation. Three structures are classified as *Total collapse*: two of them, both abandoned, are close to the crown, whereas the third is close to the left flank of the landslide.

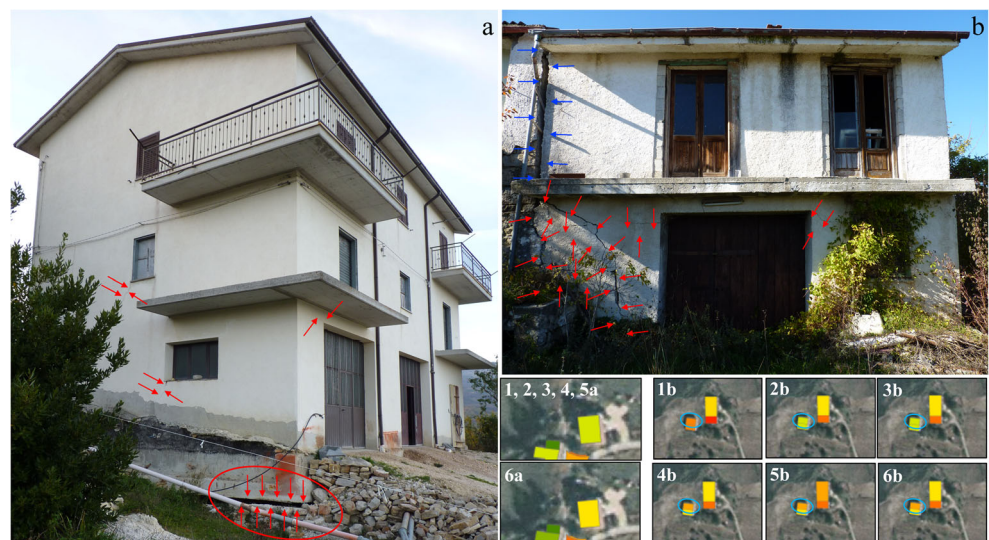
The second building is located on the left flank of the landslide and is formerly connected to another adjacent structure but is now separated by a gaping construction joint (blue arrows Fig. 12b). The building is currently abandoned, the damage to the structure includes relevant (e.g., see the red arrows in Fig. 12b) and open cracks and distortions of walls and elements as well as losses of material. The application of the six approaches shows three different levels of damage classification for this structure. The differences can be explained considering the parameters considered by the various authors. According to Alexander (1986) and Chiocchio et al. (1997), the grade of damage is evaluated as *Moderate*. Chiocchio et al. (1997) consider centimeters as the unit to describe the opening of the cracks and include severe

Fig. 12 Damage assessment for two buildings located in the study area by means of different approaches: a) three-level concrete structure located close to the landslide crown; b) two-level masonry building positioned on the left flank of the landslide. Both edifices were classified according to the (1) Burland et al. (1977), (2) Alexander (1986), (3) Chiocchio et al. (1997), (4) Cooper (2008), (5) Baggio et al. (2009), and (6) Del Soldato et al. (2017) approaches. Damage are highlighted by red arrows, and open joints between the nearby structures are shown in blue

damage in the intermediate class. Similarly, Alexander's classification (1986) considers cracks that affect structural elements and distortion angles to belong to the *Moderate* class. The approaches described by Burland (1977) and Cooper et al. (2008) categorize the recorded damage to structures in terms of the width and number of cracks more severely than the two previously mentioned schemes, and the investigated building falls into the *Severe* rank. The classifications proposed by the DPC (Baggio et al. 2009) and Del Soldato et al. (2017) are the only two that classified the building as *Very severe*. The severity and conservative results from these two approaches could be justified by their original aim to provide quick assessments of fitness for human habitation. In addition, they are unique in that they consider the extension of the damage with respect to the entire structure combined with severity. The entity of the damage is confirmed by the conservation status of the structure, which was abandoned for several years.
